Avoiding Environmental Cracking in Amine Units

API RECOMMENDED PRACTICE 945
THIRD EDITION, JUNE 2003

Downstream Segment

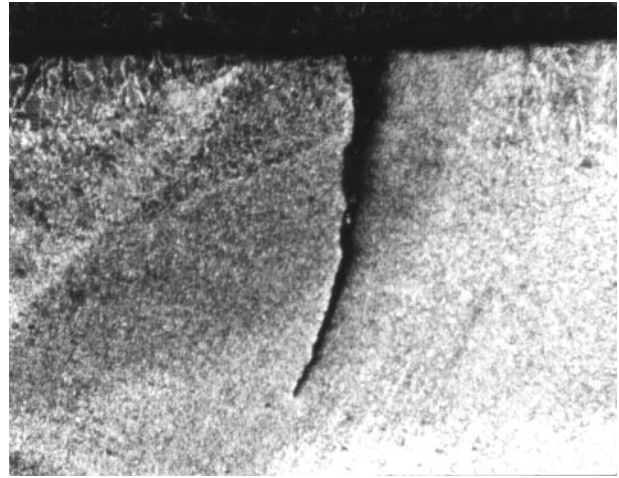
Figure A-1—Sulfide Stress Cracking in an Existing Hardened Heat-Affected Zone of a Weld

Note: Two-percent nital etch at 30X magnification.

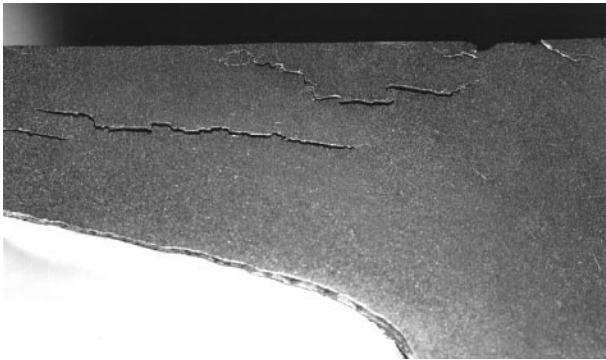
Figure A-2—Hydrogen Blisters near the ID Surface of a Carbon Steel Flange

Note: Two-percent nital etch at 4.5X magnification.

Hydrogen blistering is defined as the formation of subsurface planar cavities, called hydrogen blisters, in a metal resulting from excessive internal hydrogen pressure. Growth of near-surface blisters in low-strength metals usually results in surface bulges. Hydrogen blisters form in carbon steels when atomic hydrogen, generated by corrosion of the steel surface, enters the steel and diffuses to voids, laminations, and other internal discontinuities, such as at nonmetallic inclusions, where it collects as molecular hydrogen. Figure A-2 illustrates hydrogen blisters near the ID surface of a carbon steel flange. Steels with higher impurity levels, which tend to concentrate along planes parallel to the rolling direc-

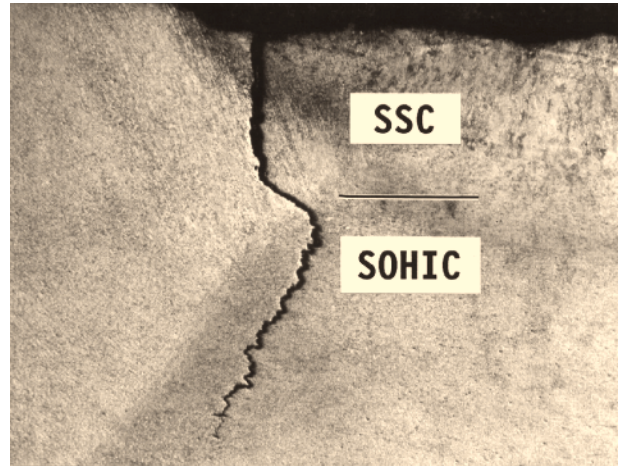
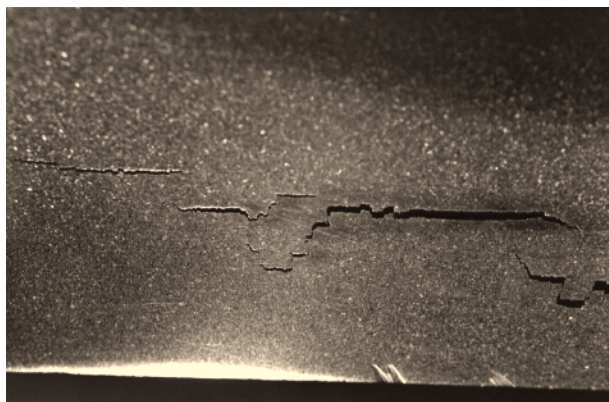
Figure A-3—Stepwise Hydrogen-Induced Cracking (HIC) in a Carbon Steel Specimen

Note: Two-percent nital etch at 5.5X magnification.

HIC is defined as stepwise internal cracks that connect adjacent hydrogen blisters on different planes in the metal, or to the metal surface. No externally applied stress is needed for the formation of HIC. The driving force for the crack propagation is high stresses at the circumference of the blisters that are caused by the buildup of internal pressure in the blisters. Interaction between these high stress fields tends to cause cracks to develop that link blisters on different planes. The link-up of blisters on different planes in steels has been referred to as stepwise cracking to characterize the nature of

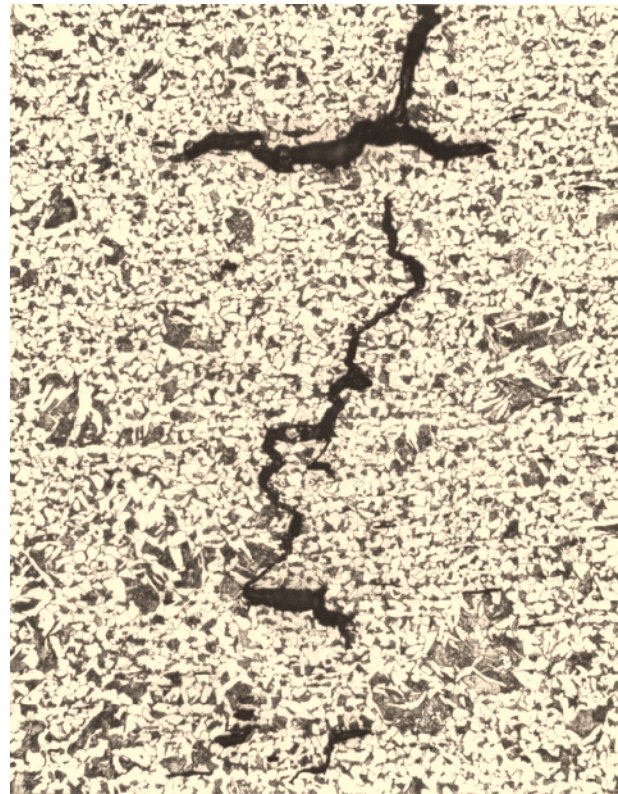
Figure A-4—Stress-Oriented Hydrogen-Induced Cracking

Note: The top panel is a two-percent nital etch at 2X magnification. The bottom panel is a higher magnification view of the crack tip shown in the top panel (two-percent nital etch at 200X magnification).

Figure A-4 shows SOHIC propagating from the tip of a sulfide stress crack in a hard heat-affected zone of a weld. In this instance, cracking progressed by a classical SSC mechanism through the hard HAZ, but then propagated by SOHIC in the adjacent lower hardness base metal. Although SOHIC often occurs at the process-exposed surface, or connects to a surface-breaking flaw, it has been found to exist subsurface only, with no connection to the ID surface. There is no evidence that hardness control of the weldment has any direct impact on reducing SOHIC. SOHIC has been found in steel with hardness less than 200 HB. However, hardness control might be of indirect benefit by reducing SSC, which can serve as an initiation point for SOHIC as illustrated in Figure A-4.

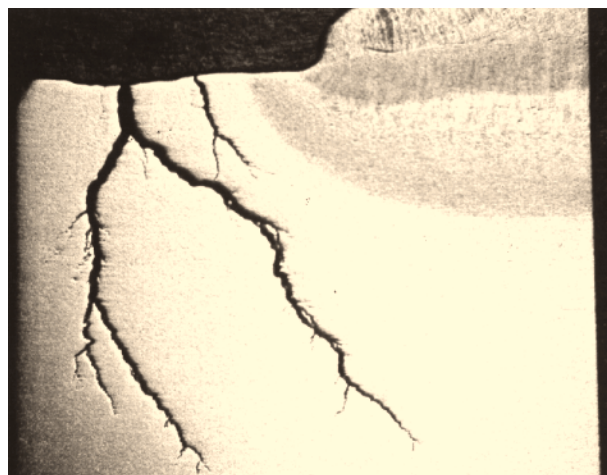
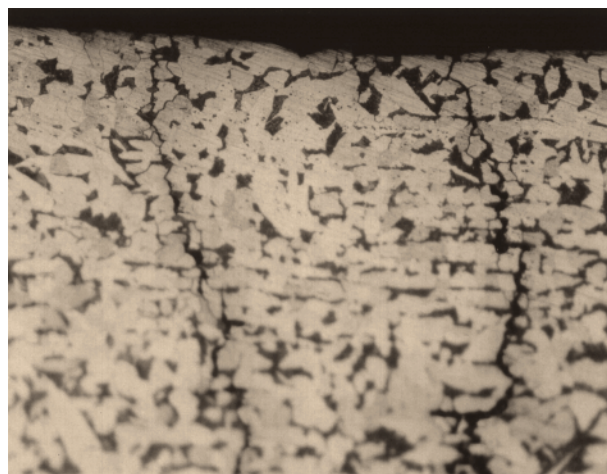
Figure A-5—Alkaline Stress Corrosion Cracking in the Vicinity of a Weld

Note: The top panel is a two-percent nital etch at 6X magnification. The bottom panel is a higher magnification view of the crack tip shown in the top panel. (2-percent nital etch at 200X magnification.)

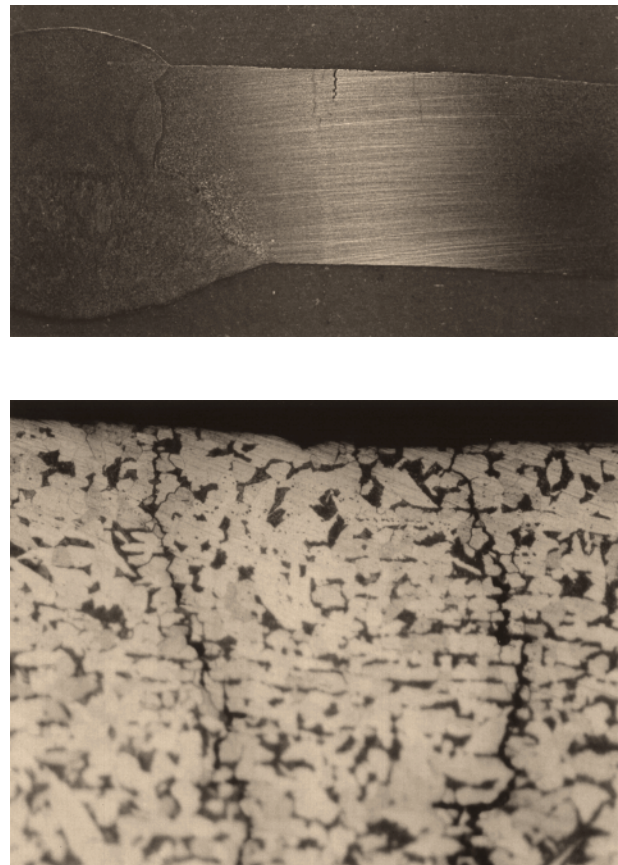
Figure A-6—Alkaline Stress Corrosion Cracking in a Pipe Weld in MEA Service

Note: The top panel illustrates alkaline stress corrosion cracks in a pipe weld in an MEA unit; nital etched specimen at 6X magnification. The bottom panel illustrates the intergranular nature of the cracks; nital etched at 200X magnification

The first example involved amine cracking (ASCC) in the overhead piping that was leading from the absorber column of an MEA unit. The line normally operated at $38^\circ C$ ($100^\circ F$), and carried a mixture of propane and butane. MEA was not usually present in the stream. However, MEA carryover may have occurred occasionally and this appears to have been the cause of the problem. Figure A-6 illustrates the parallel cracks that developed near a weld in the ASTM A106B pipe. The weld had not been stress relieved, and the material hardness at the cracks averaged 139 HB. The higher magnification photomicrograph clearly demonstrates the intergranular nature of the cracks.

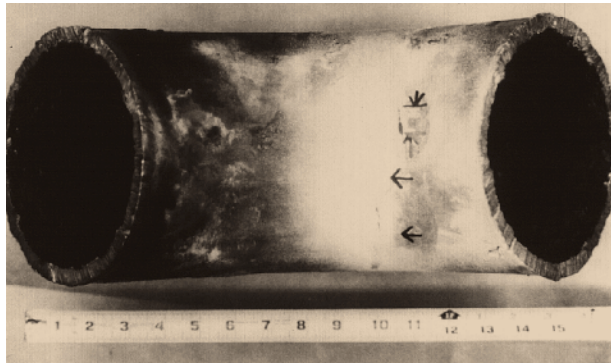
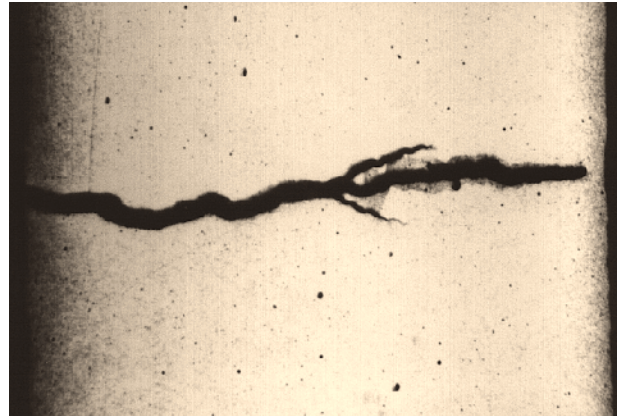
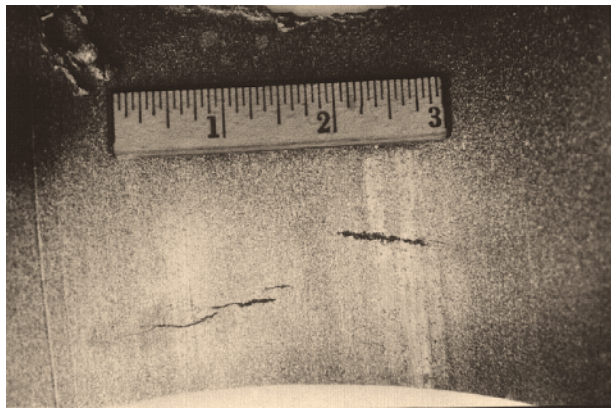
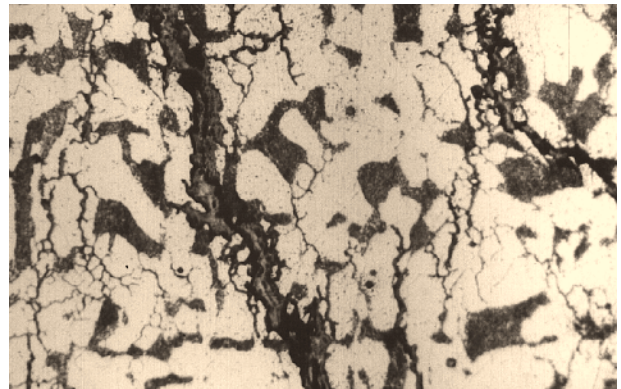
Figure A-7—Alkaline Stress Corrosion Cracking in an Elbow in DEA Service

Note: The top panel shows the location of circumferential cracks in a piping elbow from a DEA unit. The bottom panel confirms the cracks initiated on the ID surface.

The second example involved ASCC of a carbon steel elbow in the suction piping to the lean amine bottoms pump

in a DEA unit. The elbow was made to ASTM A234 WPB specifications, and the piping class required stress relief after welding. The operating temperature of the component was approximately $66^\circ C$ ($150^\circ F$). Prior to cracking, the elbow had been heated by a torch to approximately $1093^\circ C$ ($2000^\circ F$) to relieve pump strain due to piping misalignment. This heating procedure resulted in high residual tensile stresses in the elbow that subsequently cracked in service. To relieve residual stresses caused by the heating procedure, a stress relieving operation should be performed as outlined in 5.2.3.1. Figures A-7 and A-8 illustrate the intergranular cracking that initiated from the internal surface of the elbow, and verify that amine cracking occurred in the line.
